# **AFTER ACTION REPORT:**

## **WASTE MANAGEMENT AREA 15 – SITE INVESTIGATION AND REMOVAL ACTION**

**PLUM ISLAND ANIMAL DISEASE CENTER  
SUFFOLK COUNTY, NEW YORK**

**August 2007**

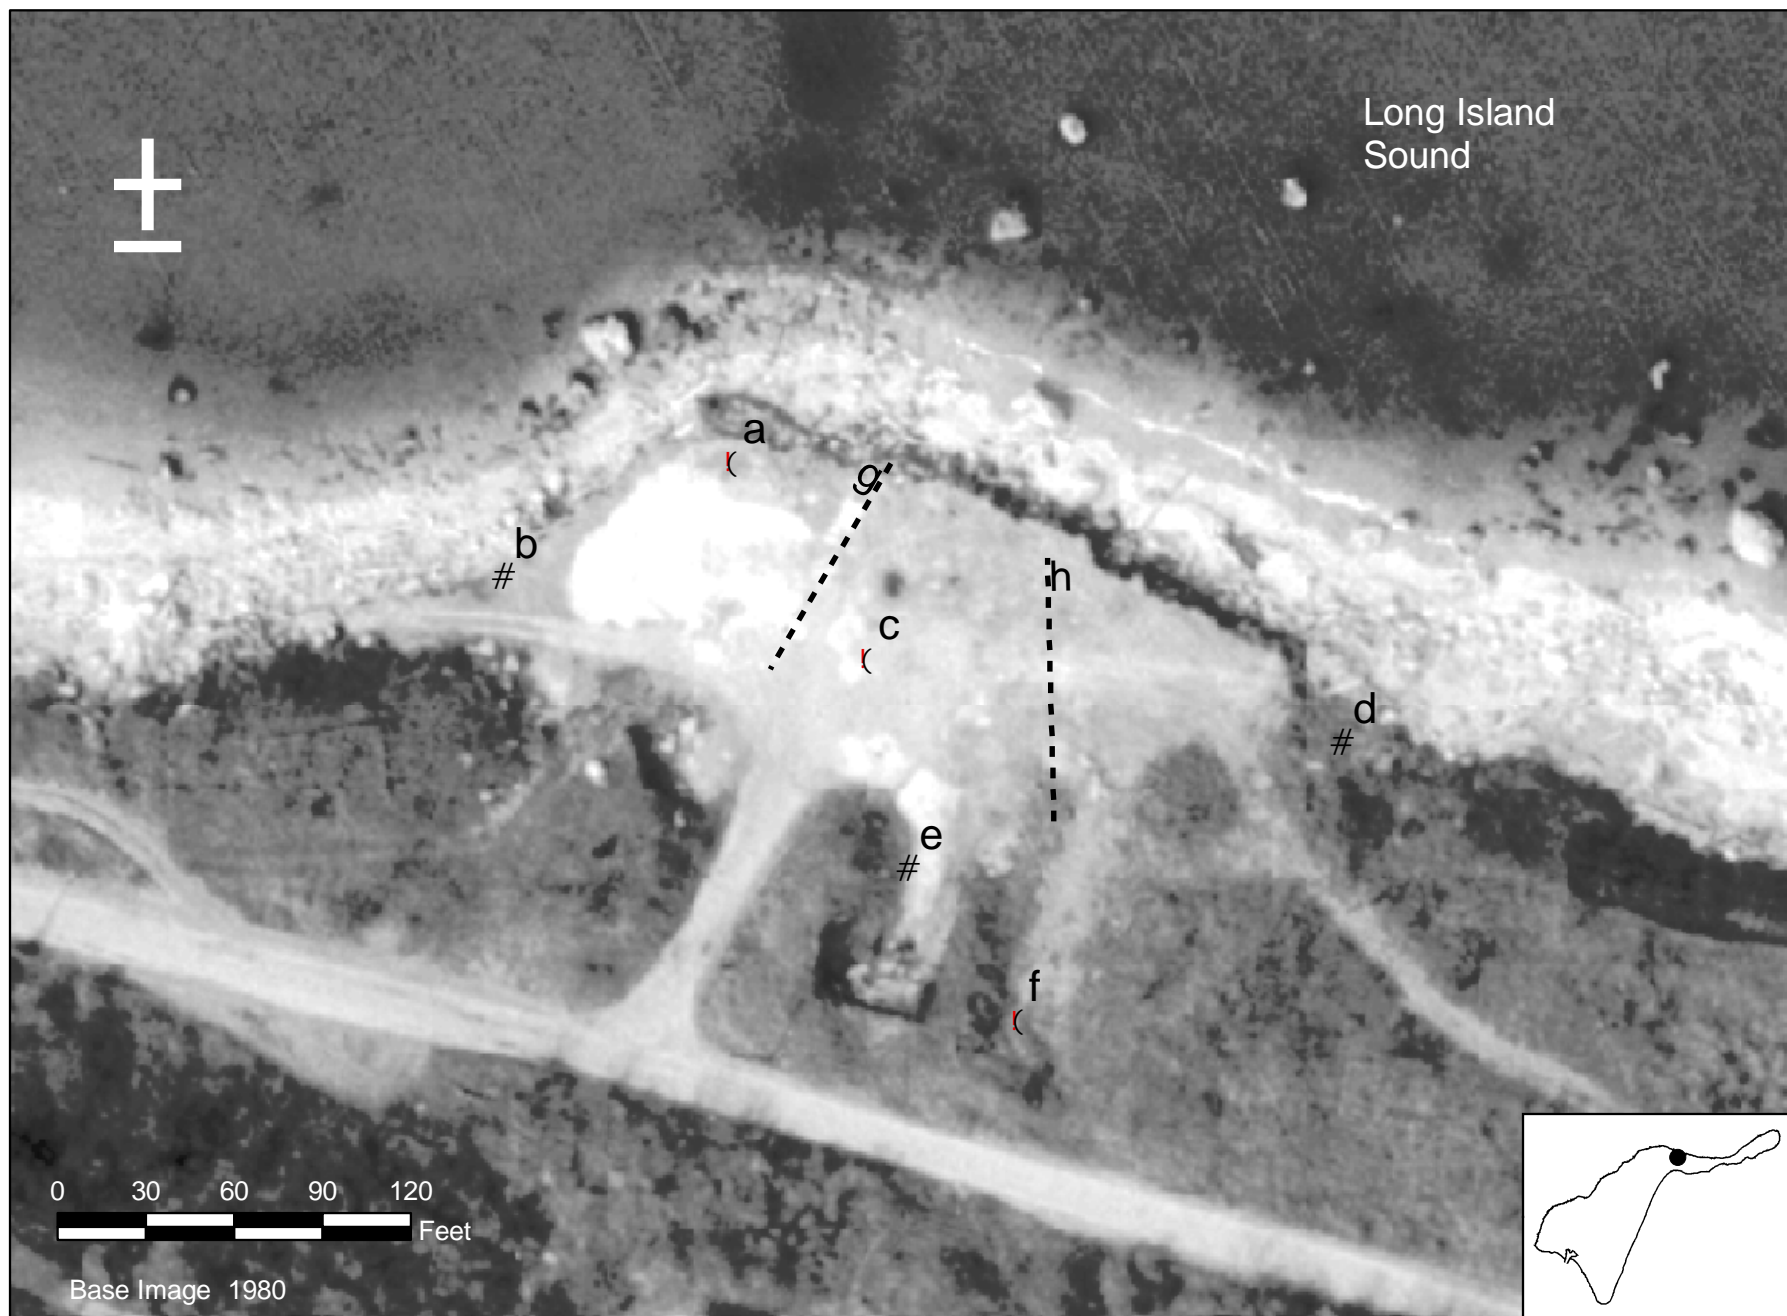
**Figure 3**  
**Plum Island Animal Disease Center**  
**WMA 15 Sampling Plan (1999)**

Test pitting (trenching) undertaken by Entech in 1999 in the eastern portion of the landfill led to the discovery of discarded drum bodies (“carcasses”) in near surface soils. Specifically, carcasses were identified in Trench “h” of that investigation. Figure 3 provides a schematic of the sampling points and positions of investigatory trenches created in 1999.

The exploratory action at Trench “h” resulted in the recovery of 3 drum carcasses. The carcasses and their residual contents were containerized for later off-site transport and disposal. Other carcasses were observed in the side walls of the exploratory trench, but were not recovered at that time. These carcasses were left in place, as it was explained to the 2001 regulatory meeting attendees, because of the nature of the investigation then underway. The purpose of the trenching was to determine general site conditions

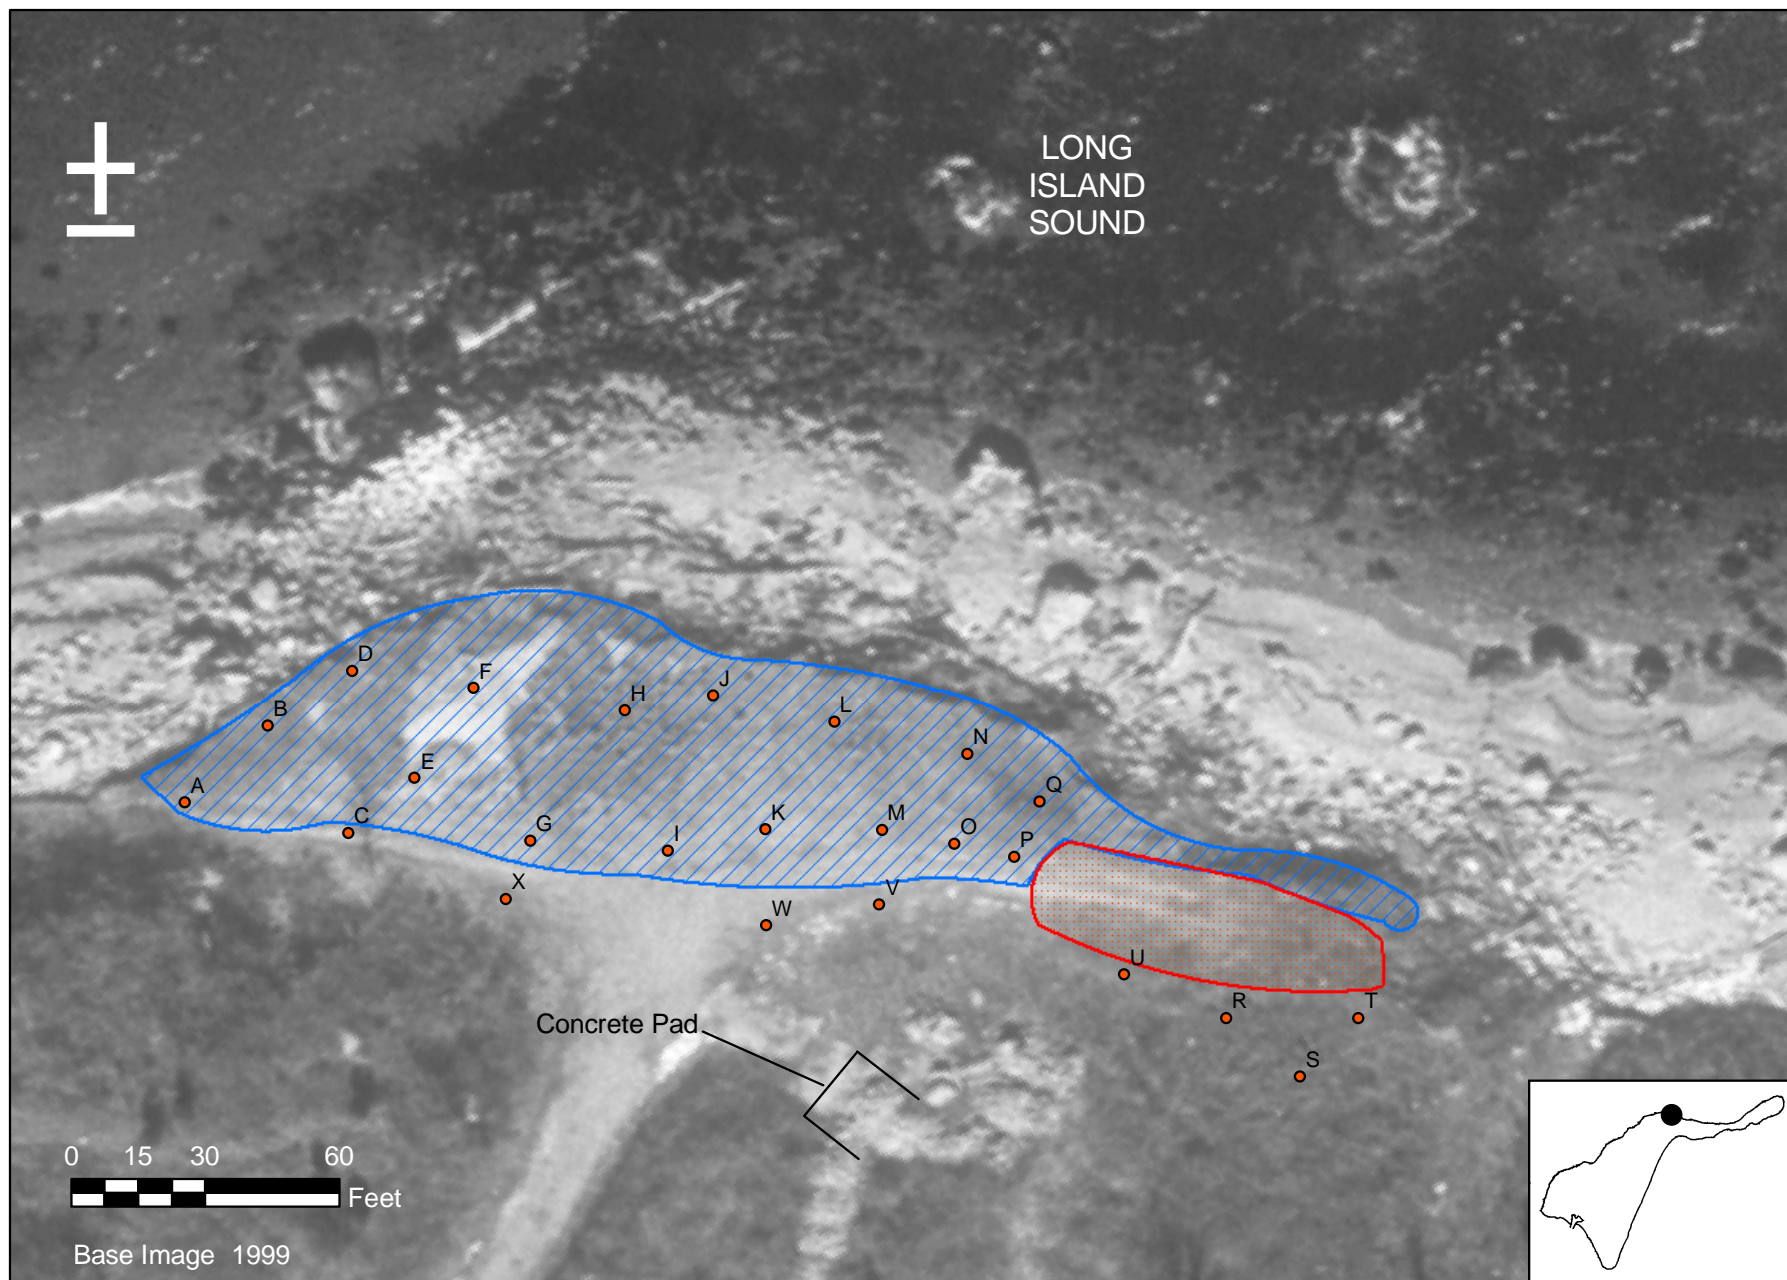
**Figure 4:**  
**Plum Island Animal Disease Center**  
**WMA 15 Site Diagram (2005-06)**

**October 2005** - Exploratory and removal operations were initiated by Entech on October 17, 2005. The first action taken was to delineate the spatial extent of the drum deposit. Entech quickly determined that the deposit (“dump”) measured approximately 30 feet wide and 100 feet long. In most instances the drums were found just beneath the soil surface; however, carcasses were occasionally detected up to 6 feet below ground surface (bgs). The position of this dump relative to the footprint of WMA 15 is portrayed in Figure 4.

Given the observational results of this action, Entech concluded that subsurface waste deposition within WMA 15 was largely confined to the northern half of the site. The deposits appeared to taper, gradually thickening as they were deposited northward towards the coast. The area impacted by this past disposal activity is "sandwiched" between the coastal bluff and the intra-site roadway historically associated with the landfill. The spatial limits of this deposit are generally delineated on Figure 4.

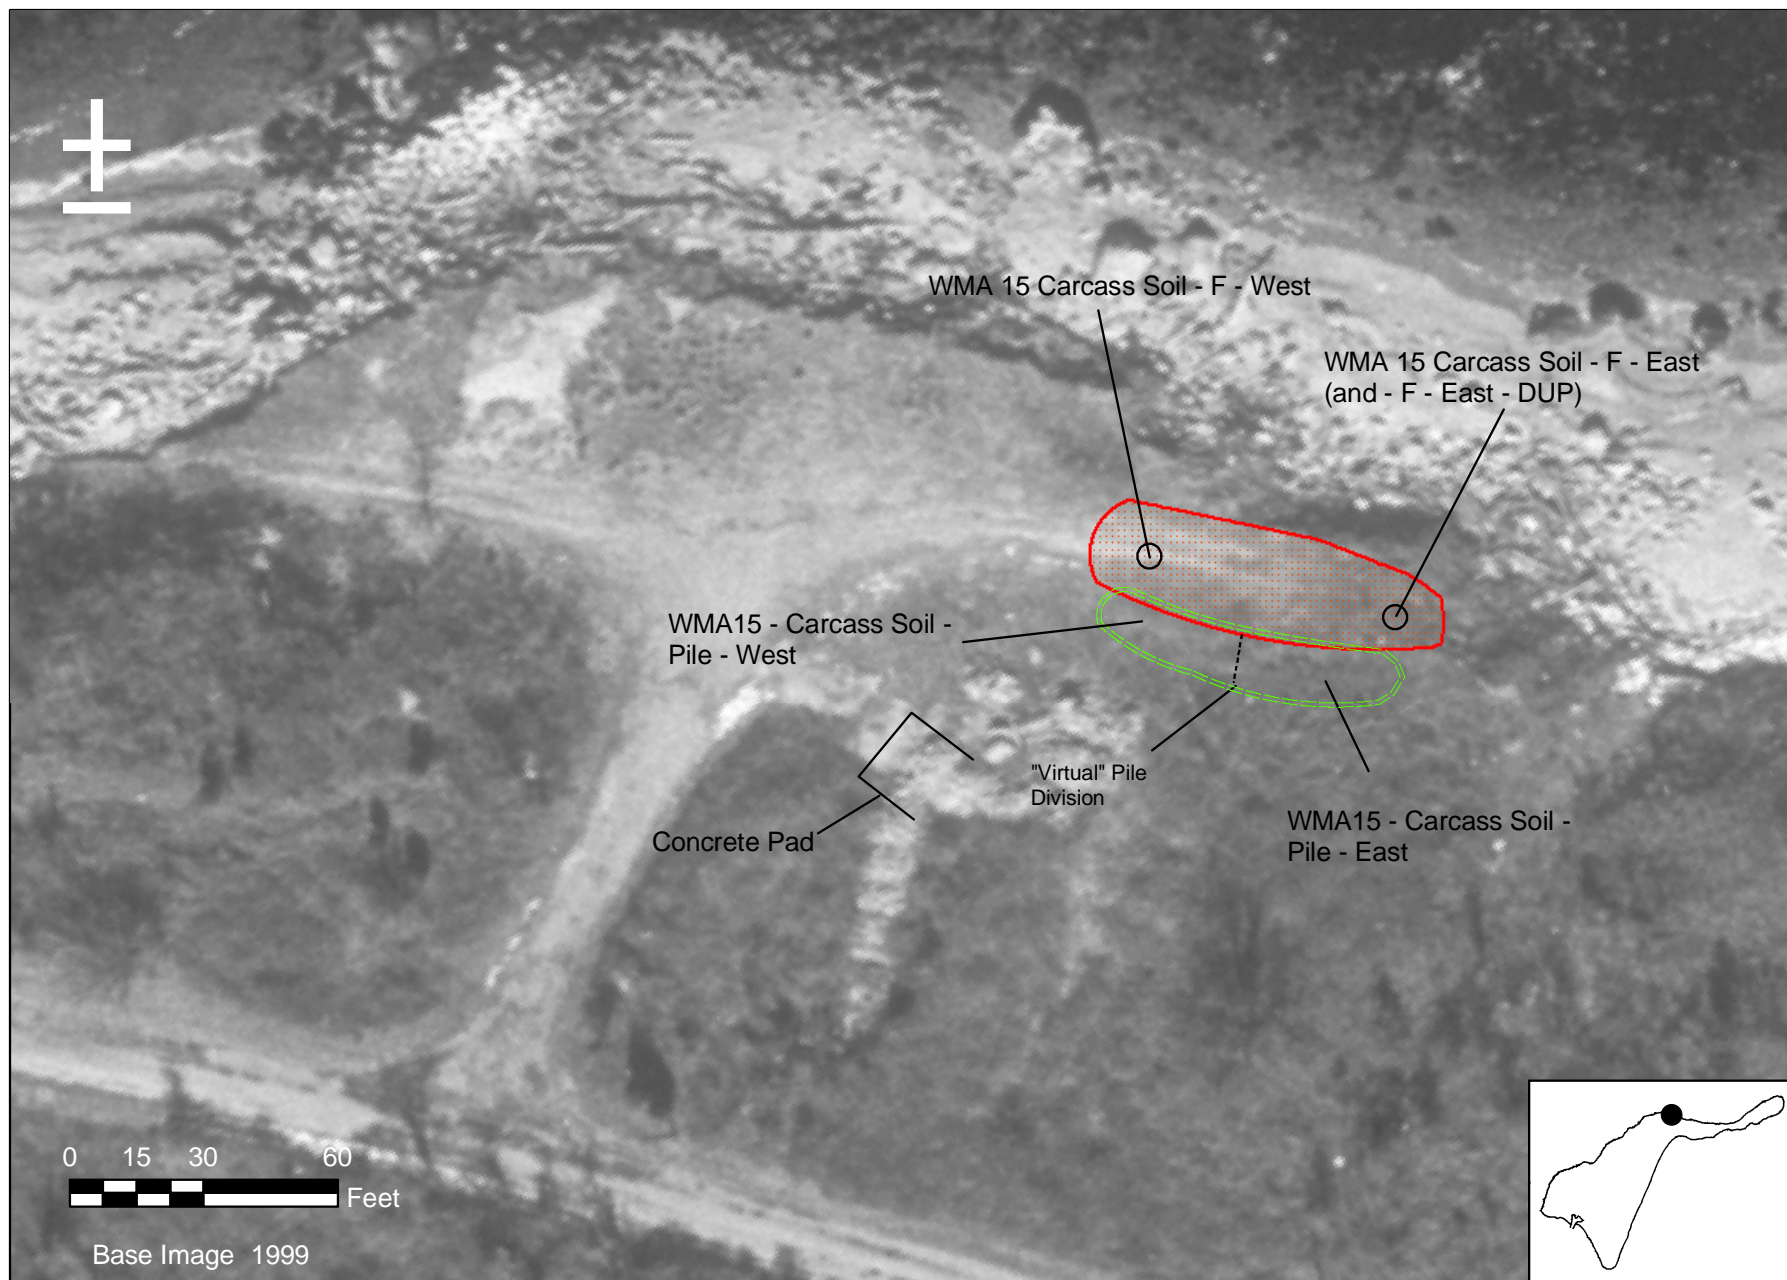
**Figure 5:**  
 Plum Island Animal Disease Center  
 WMA 15 Drum Dump Sample  
 Locations

Two grab samples from the floor of the excavation were collected at points below that of the original drum burial "horizon". These subsurface samples were collected to determine if contaminants had passed downward through the soil matrix over time. These sample points were developed by excavating two shallow pits along the central east-west axis of the excavation. One sample was used to represent the eastern half of the excavation while the other reflected conditions in the western portion of the excavation.

The grab samples were collected from the sidewalls of the pits at points that were clearly below the overlying, disturbed earthen strata. These samples were evaluated for Target Compound List (TCL) semi-volatile organic compounds (SVOCs), organochlorine (OC) pesticides, PCBs, and Target Analyte List (TAL) metals. Figure 5 presents the locations of these sample points.

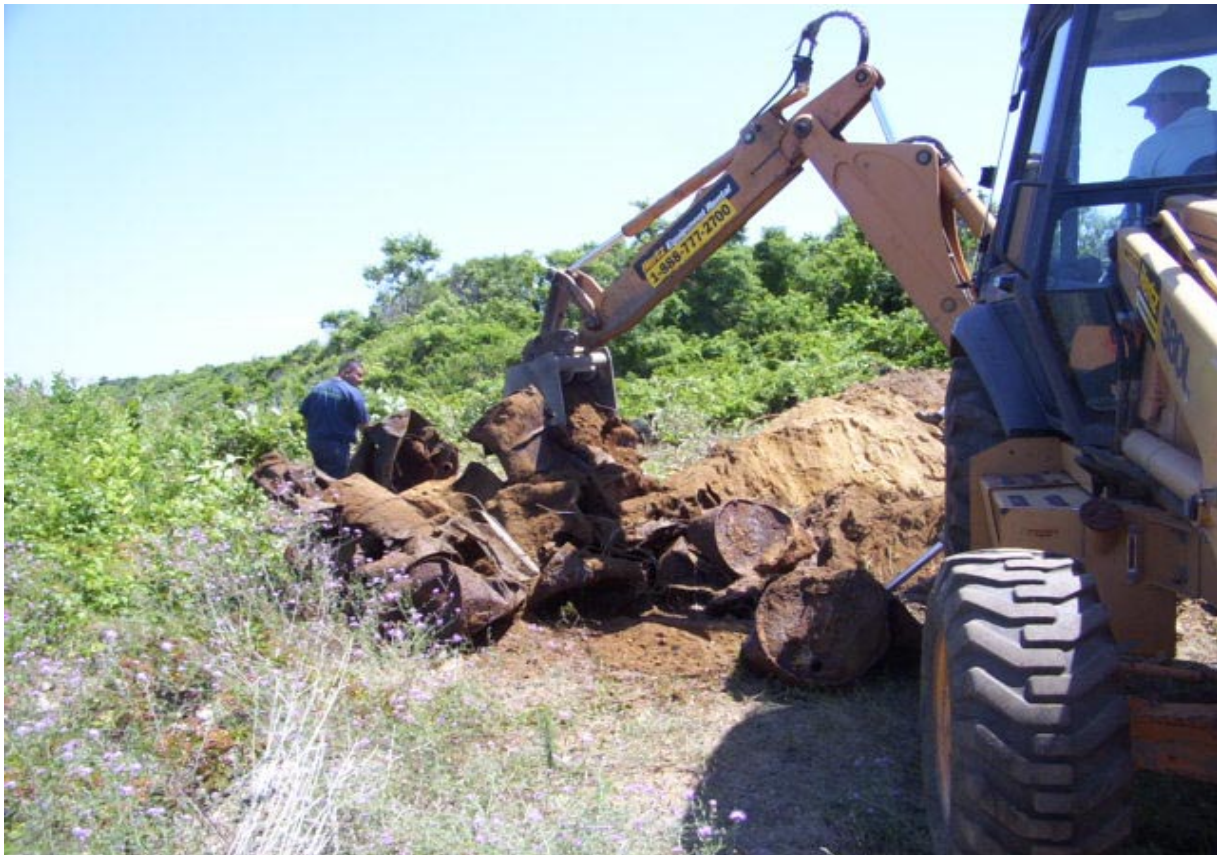
**Figure 1 – Initial excavation of drum carcasses from the eastern portion of WMA 15.**

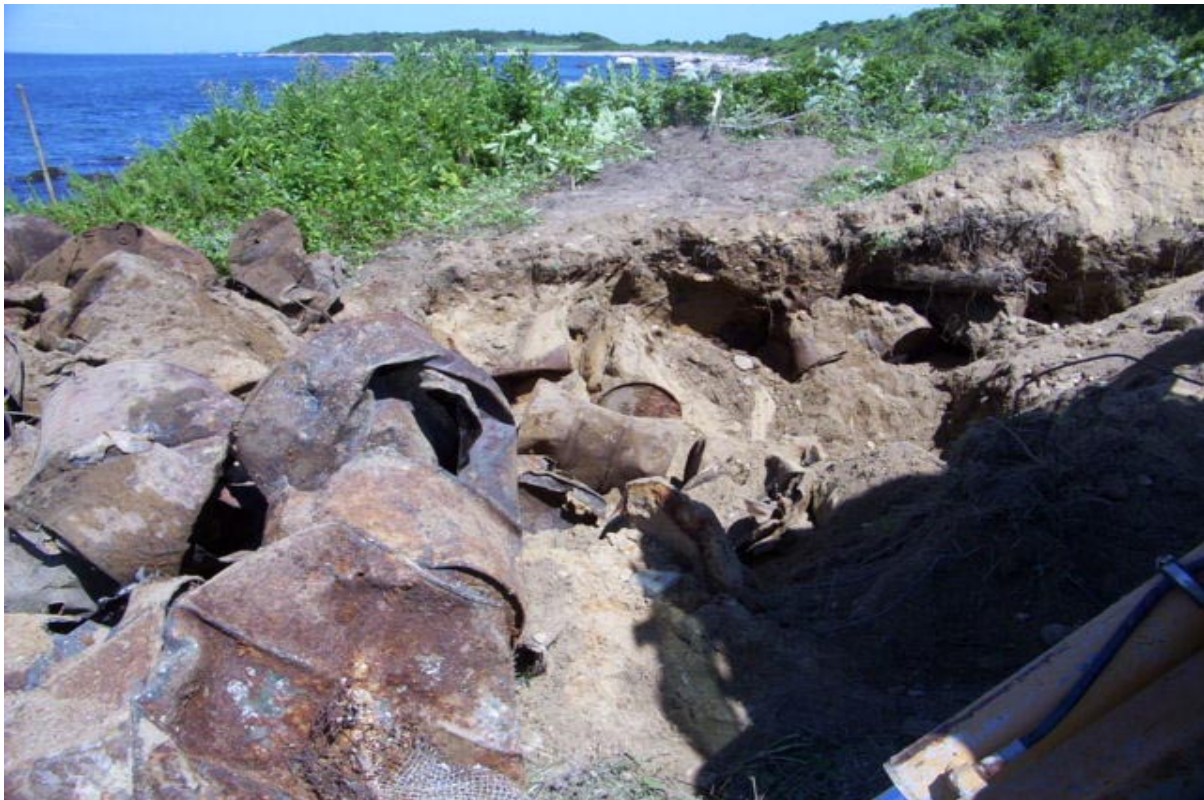
**Figure 2 – Typical view of drum carcasses removed from the drum dump at WMA 15.**

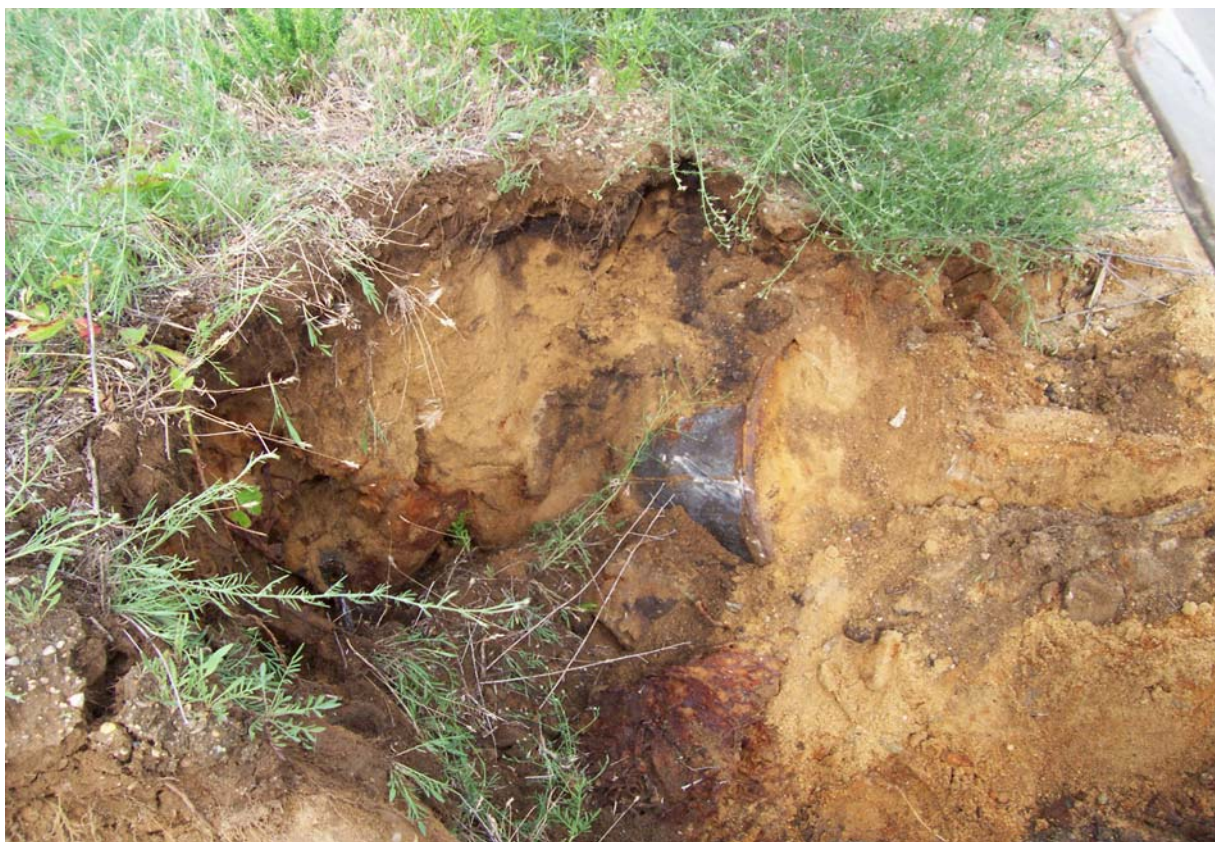
**Figure 3 – Typical view of buried drum carcasses in the drum dump at WMA 15.**

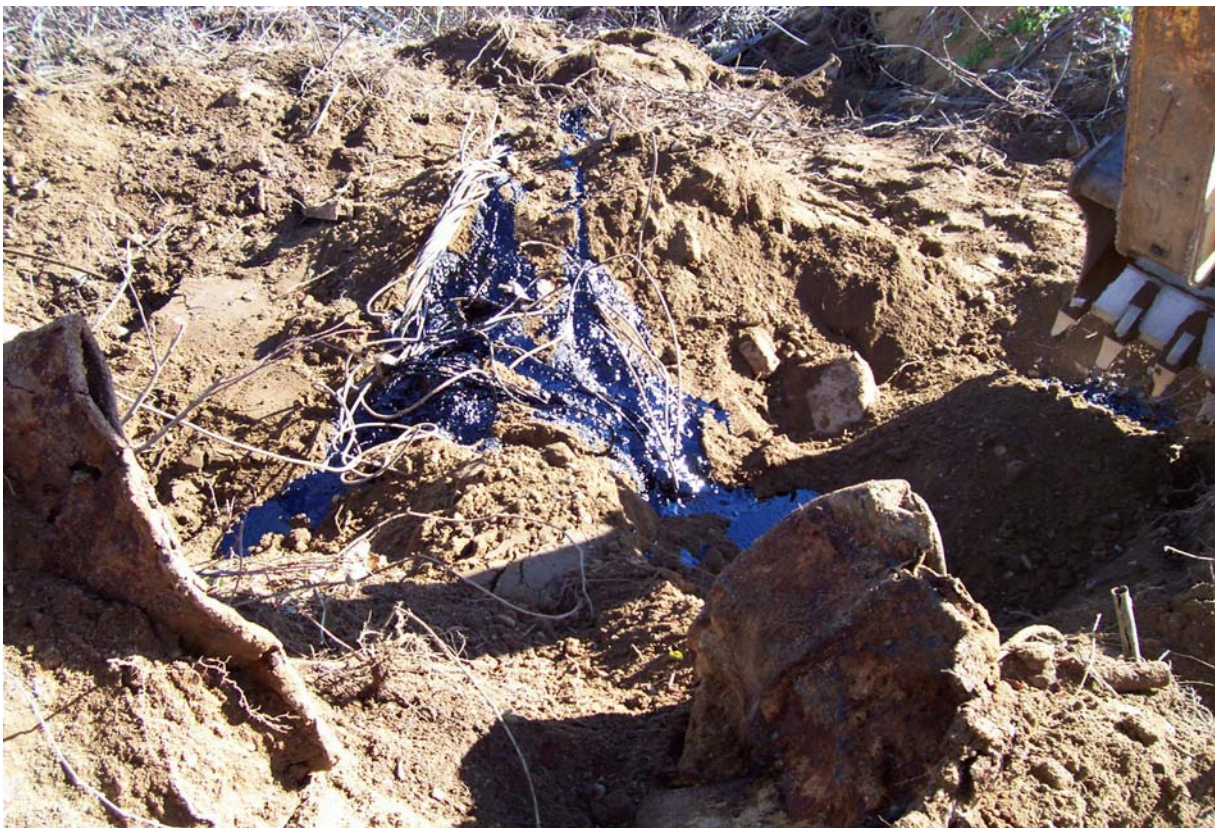
**Figure 4 - View of heavy oil (No. 6 fuel oil) released from buried drum encountered during drum carcass removal operations in October 2005.**

Unlike the tarry materials previously encountered, the content of this intact drum was a very fluid, dark, free-flowing material. A petroleum smell was evident in the air soon after the incident and a PID reading taken immediately after the release returned readings ranging from 8 to 72 ppm for non-specific volatile compound emissions. The incident was reported to the facility's emergency response personnel and a containment/clean-up initiative was begun immediately. Photographs of the incident were taken; several representative images documenting this release have been included in Appendix A.

Securing and cleaning up the release required most of the day to complete. The clean-up generated four (4) recovery drums of oil contaminated wastes. These wastes were primarily comprised of oil contaminated soil, the carcass and residual contents of the breached drum itself, and miscellaneous personal protective equipment (PPE) and clean-up supplies. The drums were later removed from the site and staged in Building 67 for subsequent pick-up and disposal. The other previously exhumed carcasses collected during the day (87 individual carcasses in all) were secured on the plastic-covered pad discussed above.

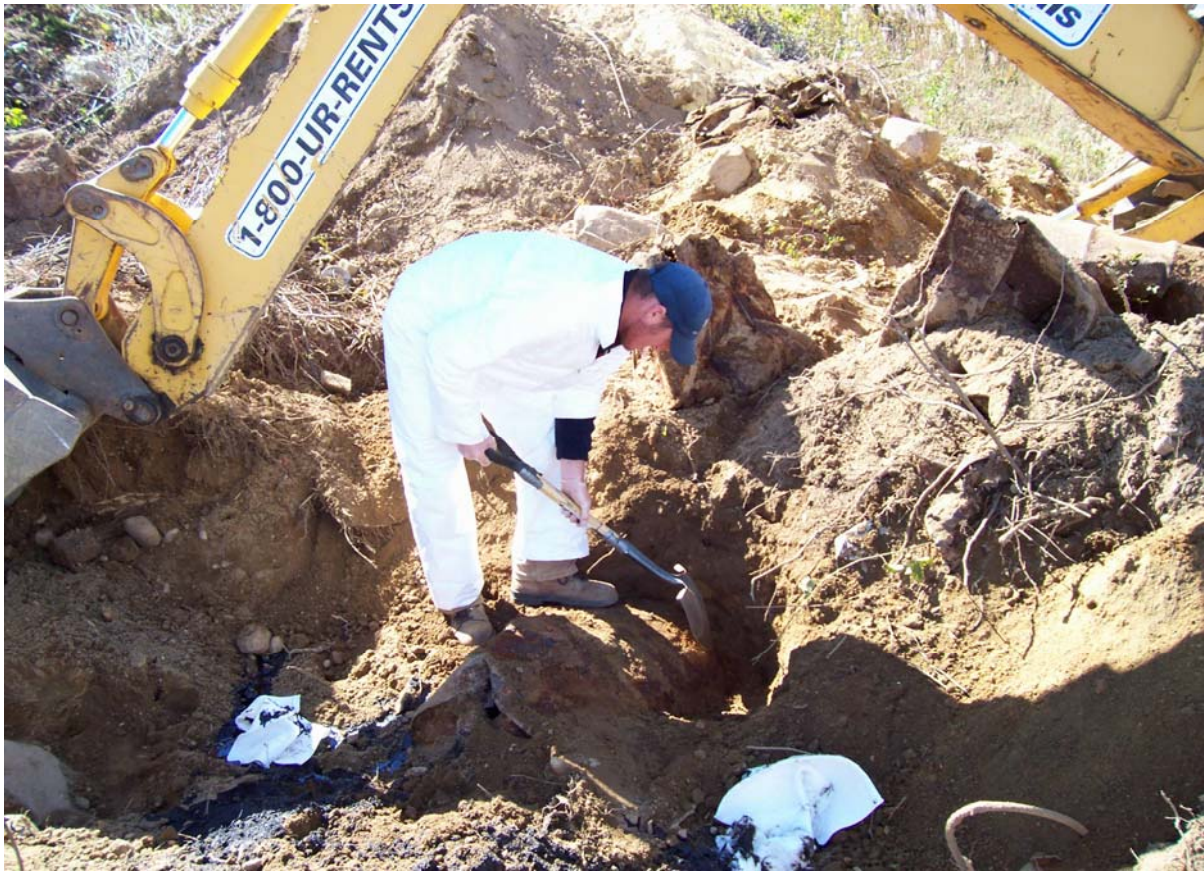
**Figure 5 – Post-release exposure of fuel oil filled drum encountered in October 2005.**

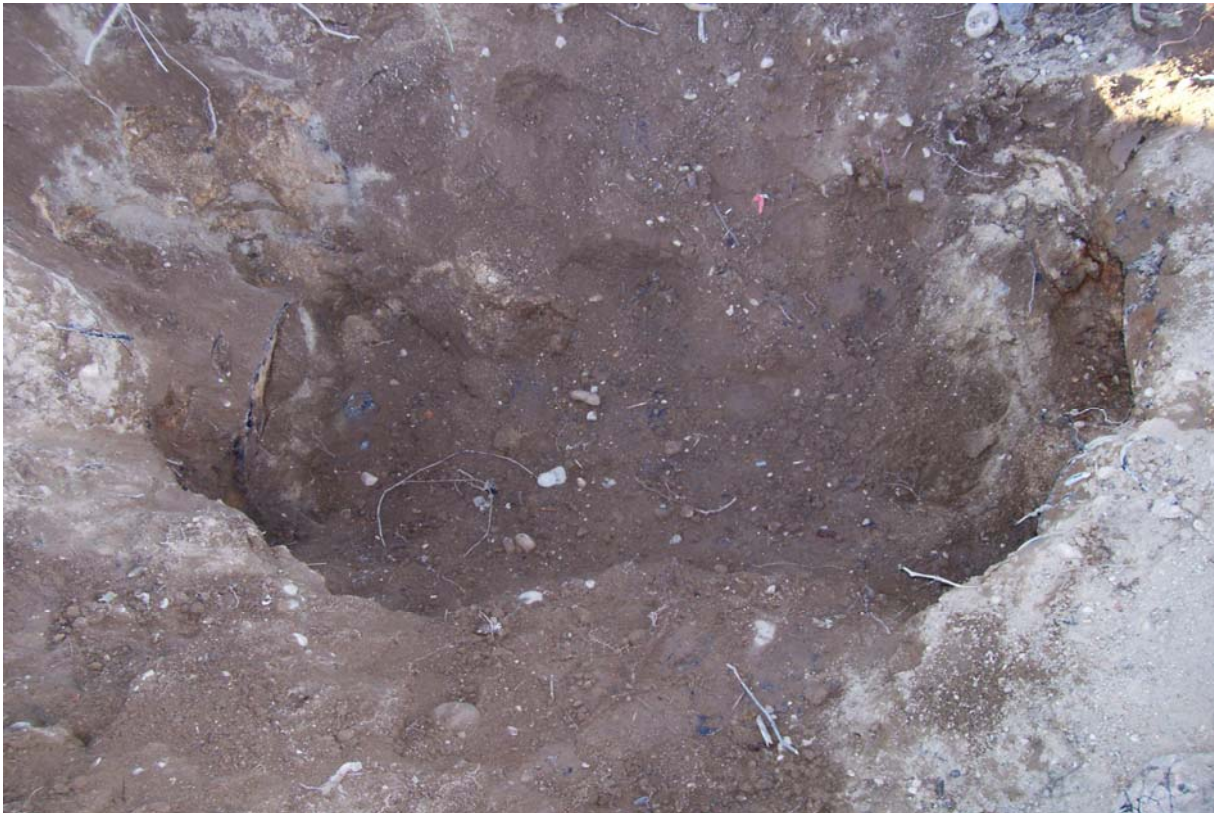
**Figure 6 – Post removal view of the fuel oil drum release site. Note partially exposed drum carcasses immediately to the right and left of the excavation.**

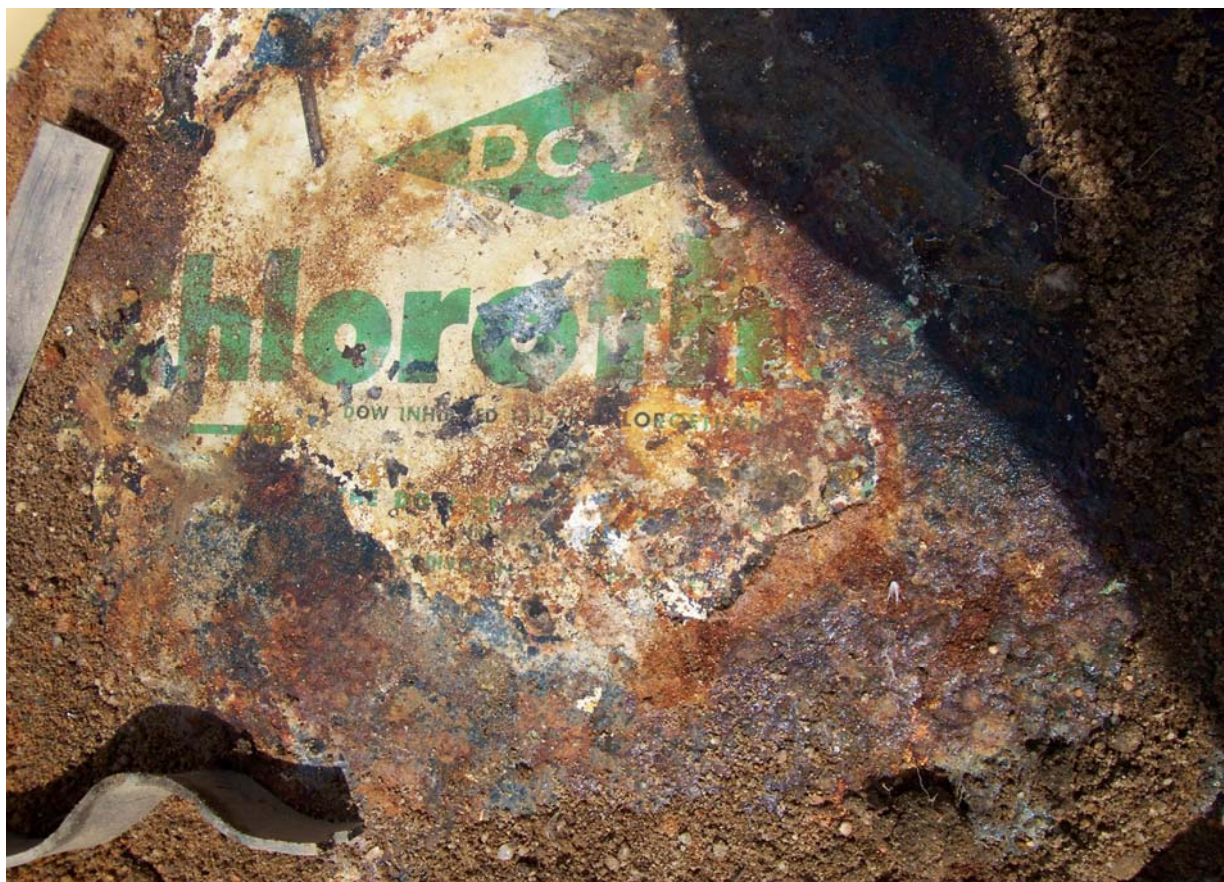
Figure 7 – Drum label on exhumed carcass. This drum contained spent motor oil.

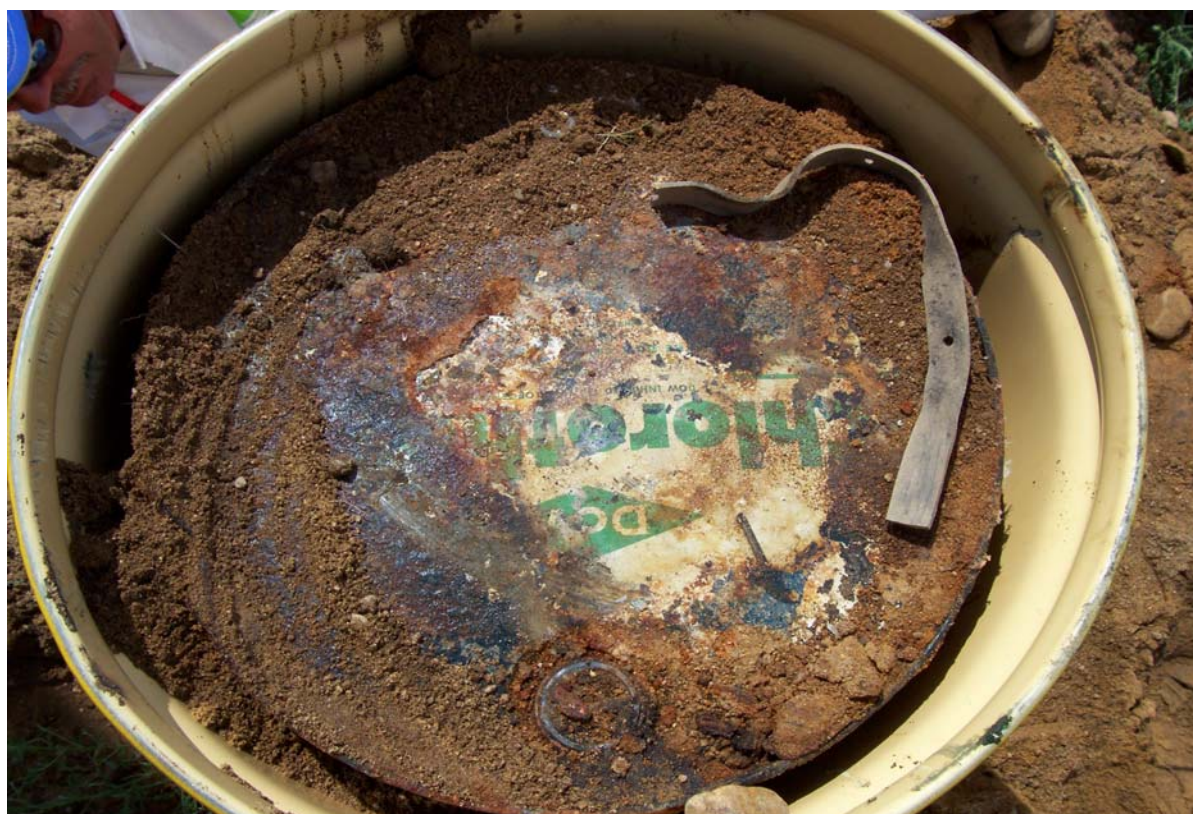
Figure 8 - Spent motor oil drum and contaminated soil placed in an overpack drum.

In addition to the recovered drum carcasses discussed above, four (4) salvage drums containing partially oil-filled drum bodies and/or contaminated soil and clean-up materials were generated by the end of the July removal action. One drum body recovered from the dump was determined to contain #6 oil (fuel oil); a second drum held spent motor oil. The "motor oil" drum was observed to have legible print on one side. The green and white lettering and symbols on that drum identified it as having once contained a DOW Chemical product. Specifically, the signage referred to the contents as "DOW inhibited 1,1,1, Trichloroethane". Elsewhere on the body of the drum the partial wording "chloroeth..." was observed. A photograph of this drum and its signage is provided in Appendix A. Given the clearly oil-based content of this drum, the lack of a solvent smell, and negative readings from the PID, it was determined that the drum had been re-used as a convenient container for the oily wastes generated elsewhere on the island.

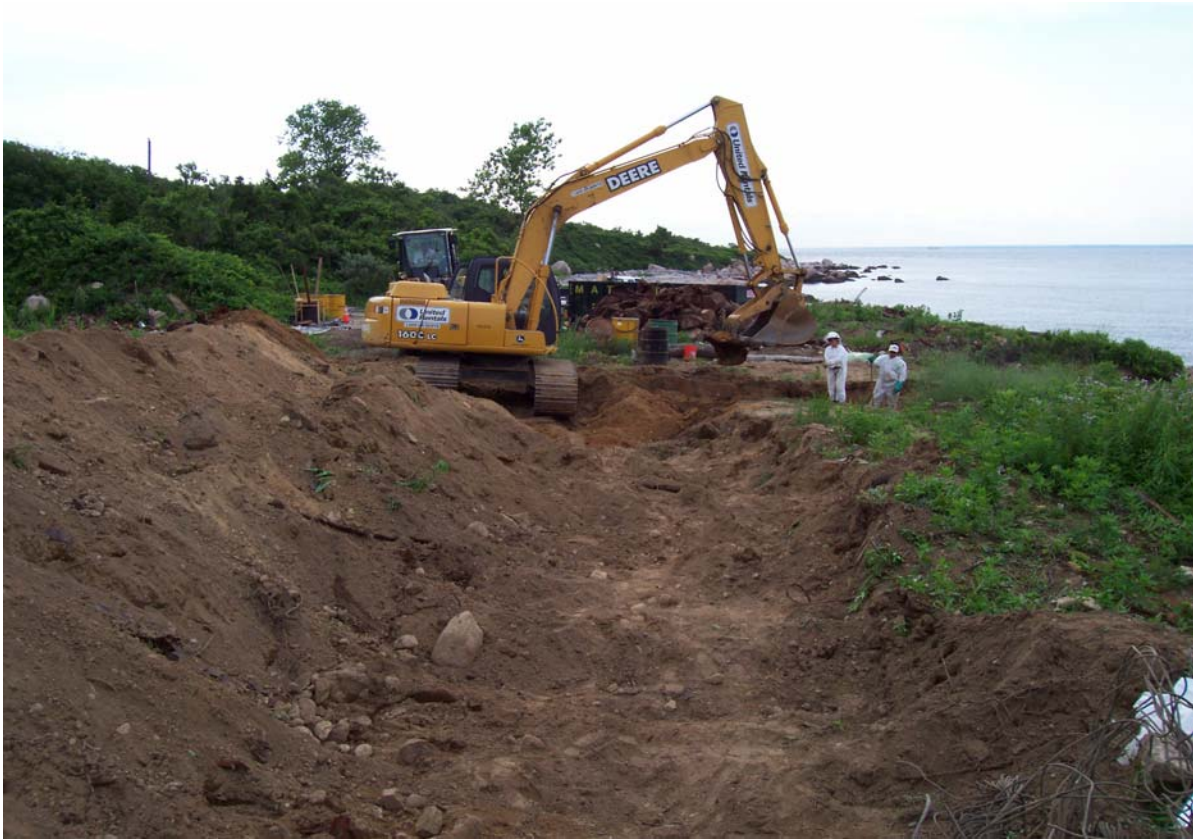
**Figure 9 – Full-scale exhumation of the drum dump at WMA 15. Over 300 drum carcasses were ultimately removed from the eastern portion of this landfill.**

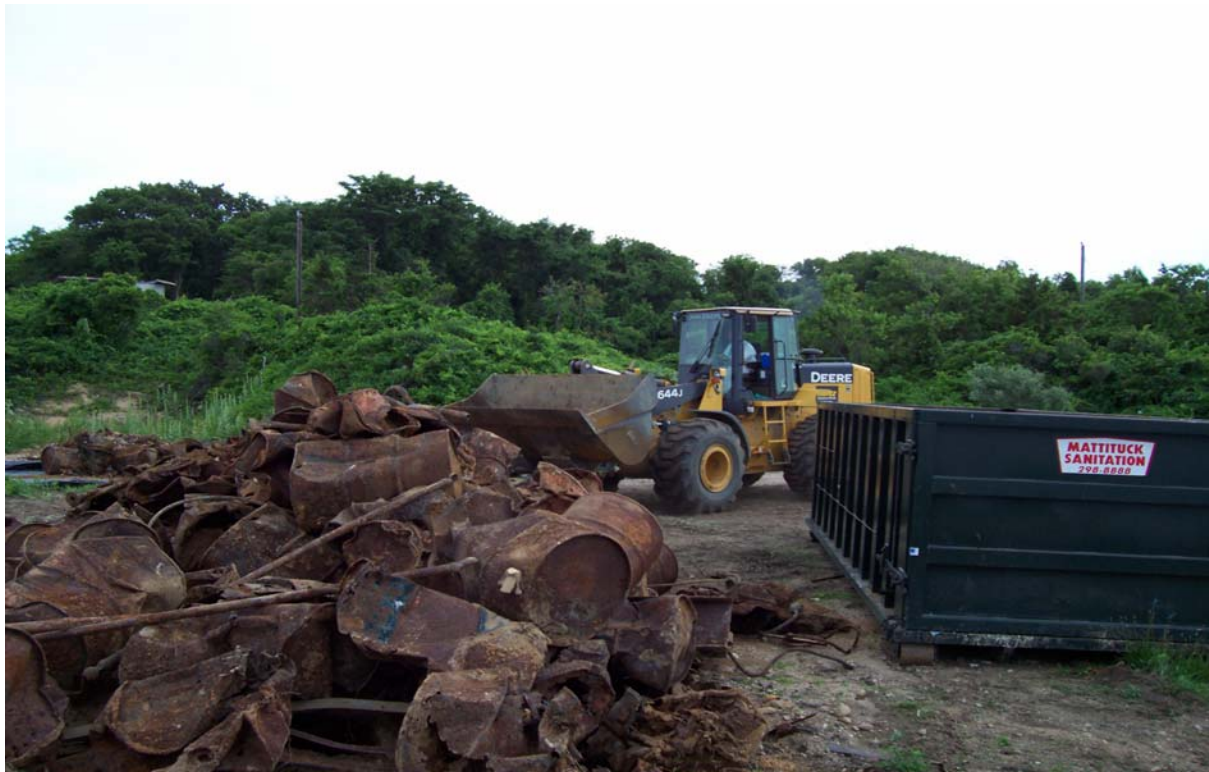
**Figure 10 – “Clean” (oil free) drum carcasses readied for shipping via roll off box to a local metals recycling facility on Long Island.**

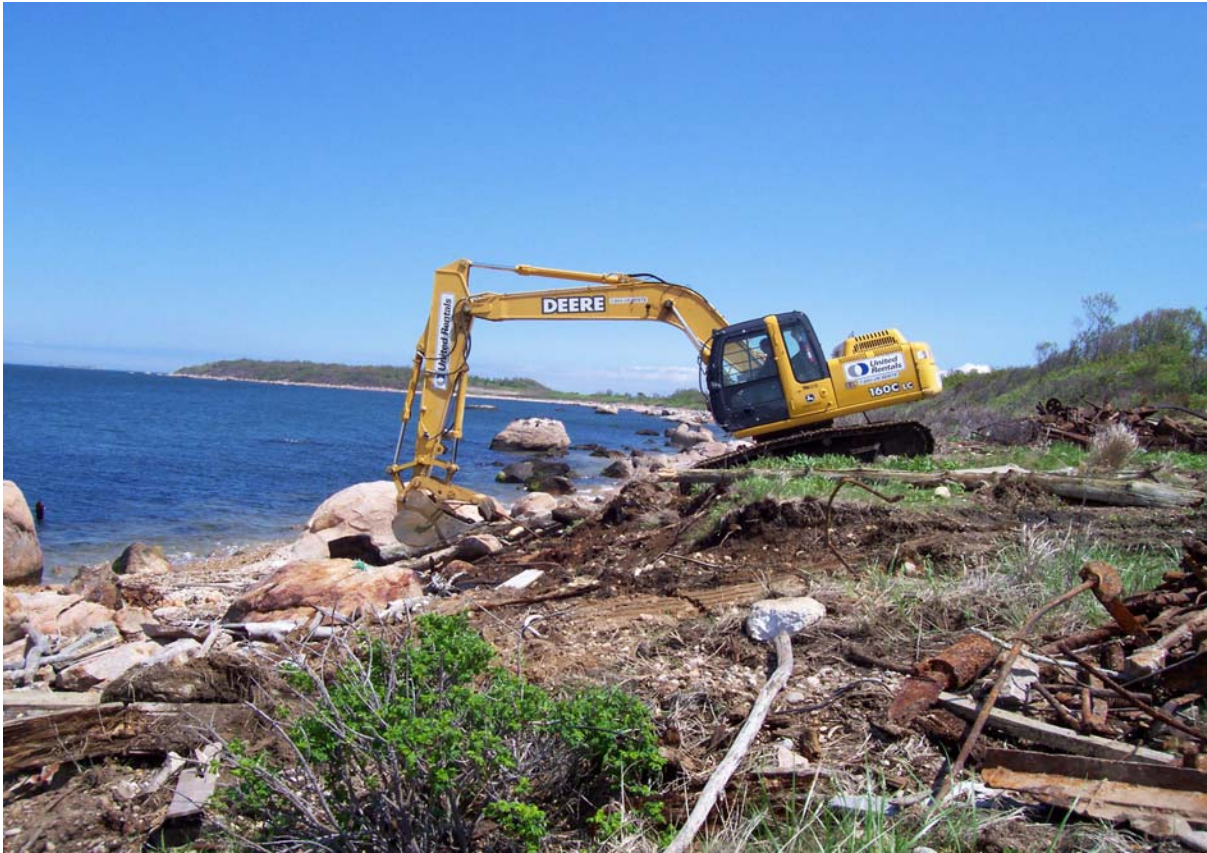
**Figure 11 – Recovering scrap metal from the landfill bluff at WMA 15. This metal was later transported to a local Long Island metals recycling center.**

The recovery and removal of scrap metal and general debris from the bluff of WMA 15 began in May 2006. Like the drum carcass removal activities that occurred during 2006, the removal of this surface debris was conducted on an *ad hoc* basis. The removal action was used to supplement operational activities associated with the on-going IBE Project. Attention was turned to the recovery of scrap metal (and drum carcasses) when poor weather or malfunctioning equipment associated with the IBE Project occurred. Several photographs documenting the metal recovery process have been included in Appendix A.

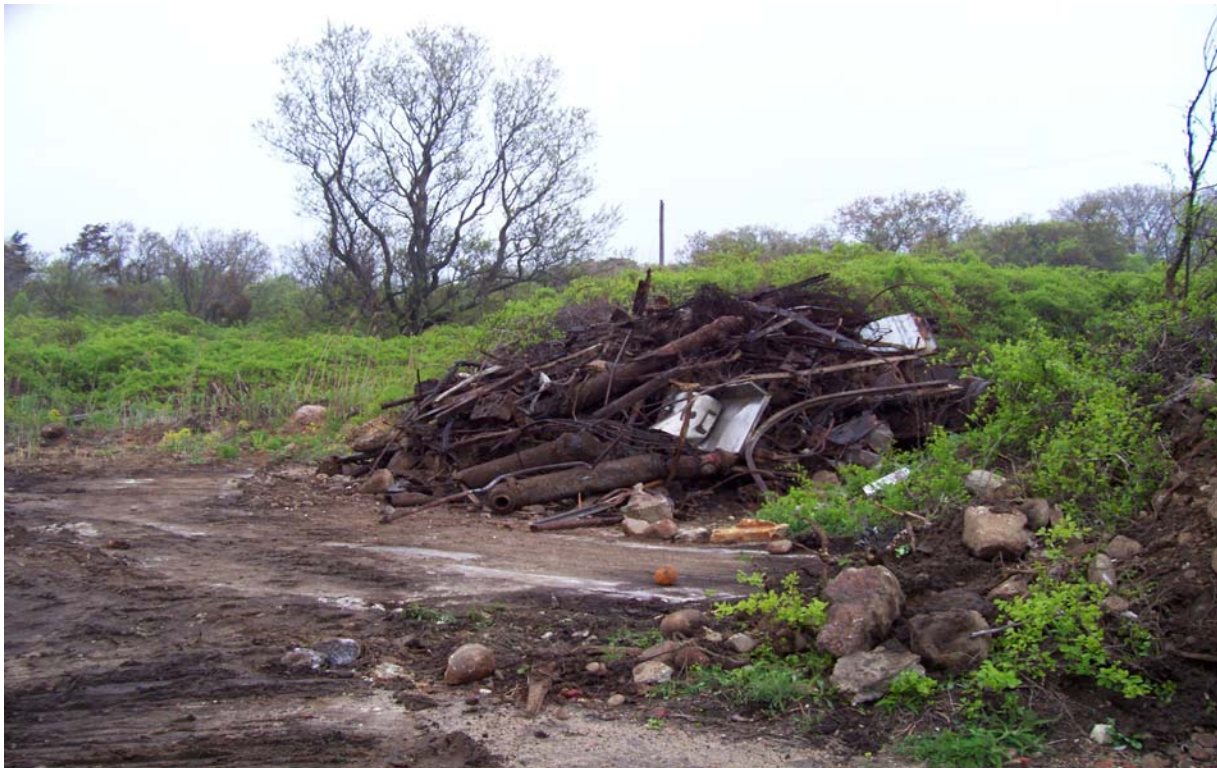
**Figure 12 – Stockpiled scrap metal recovered from WMA 15 awaiting transport to an off-island recycling center.**

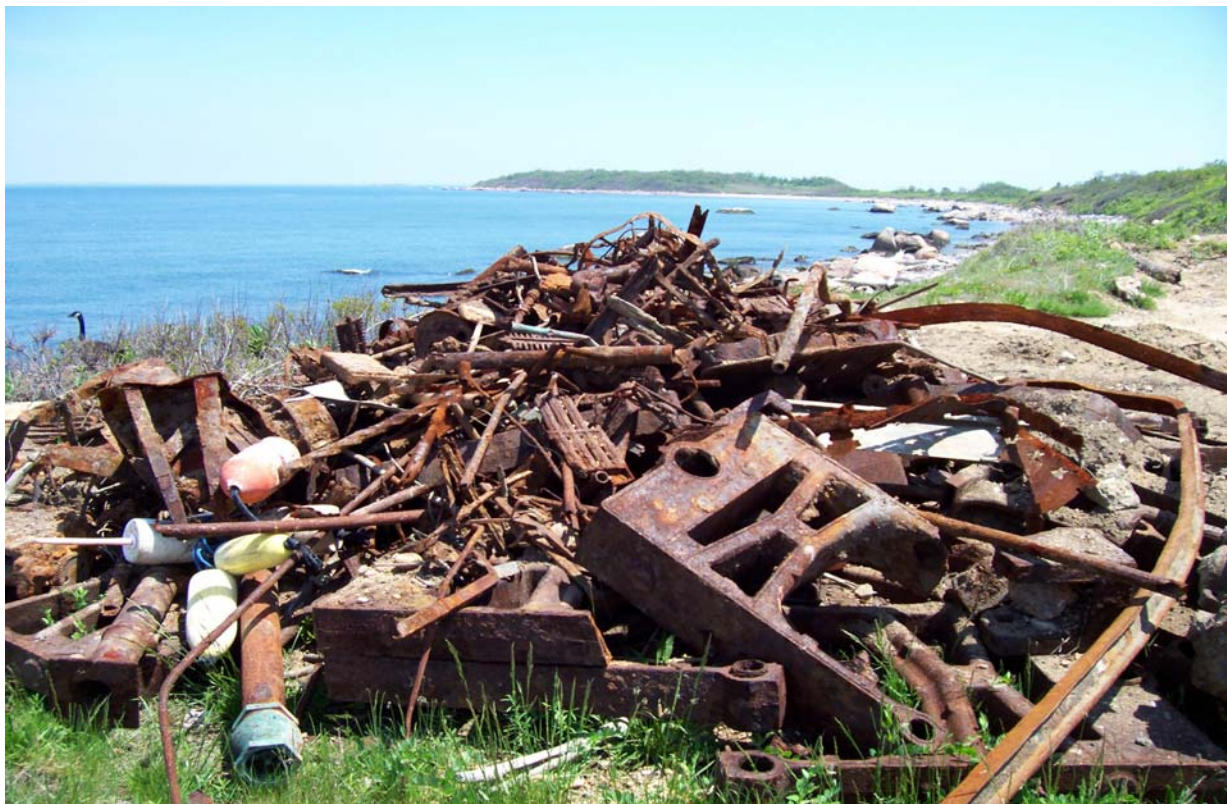
**Figure 13 - Unsorted scrap metal and debris from the bluff and shoreline of WMA 15.**

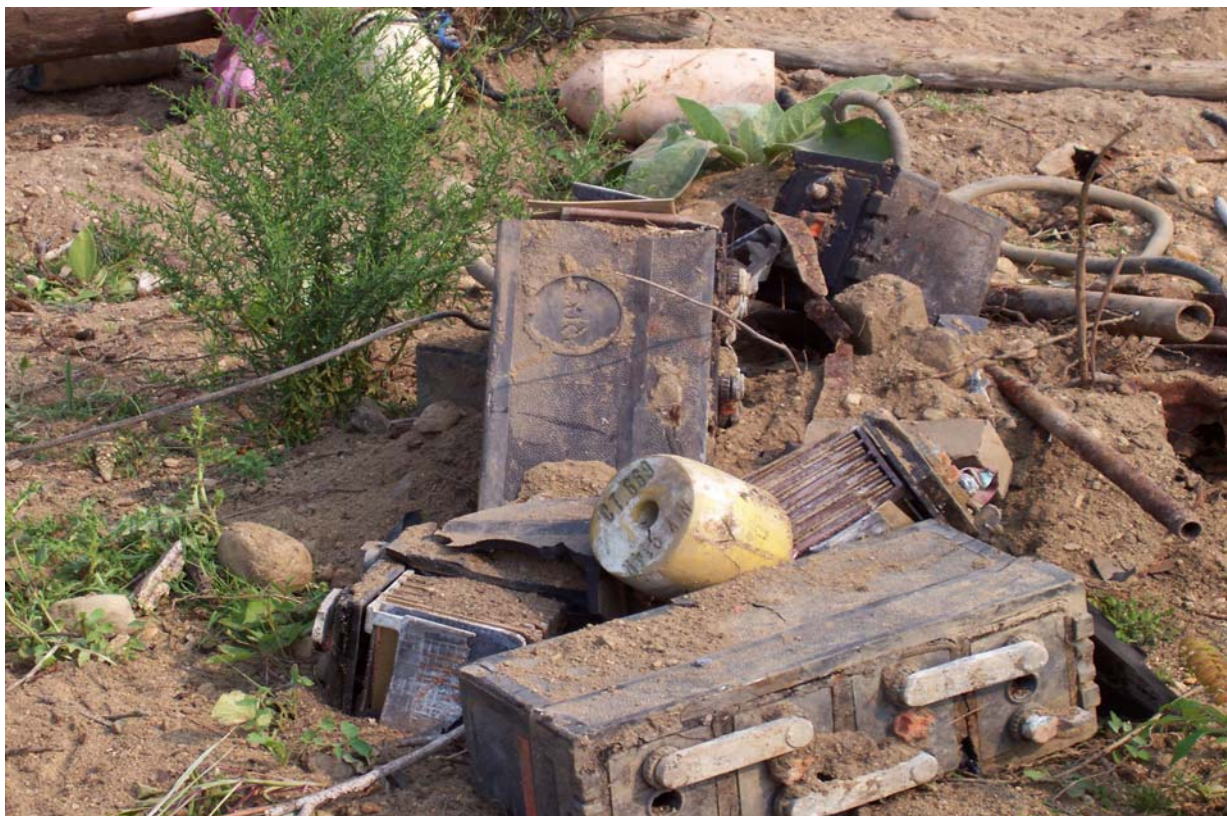
**Figure 14 - Example of debris items removed with scrap metal deposits from WMA 15.**
